**SAS Superstructure**

**Daily Diary Report by Bid Item**

Contract No.: 04-0120F4

Diary #: 887 Const Calendar Day: 421 Date: 30-Jul-2013 Tuesday

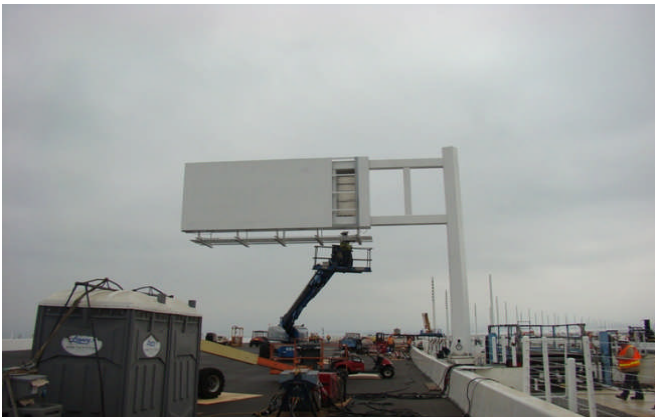
Sign structure along the W-Line near crossbeam 18 which was surveyed today for level and plumbness.

- Shot the W-Line sign structure near crossbeam 18 for the sign pole plumbness and the sign being level. Used the total station to take reflectorless shots of the 4 corners of the sign defining the cross slope. The marks placed the other day using the manlift per the assistance of Bleyco electricians was used to check for plumb in the transverse and longitudinal direction of the bridge. The sign was measured close to level, however the pole vector out of plumb was 61mm in the Northeast direction.

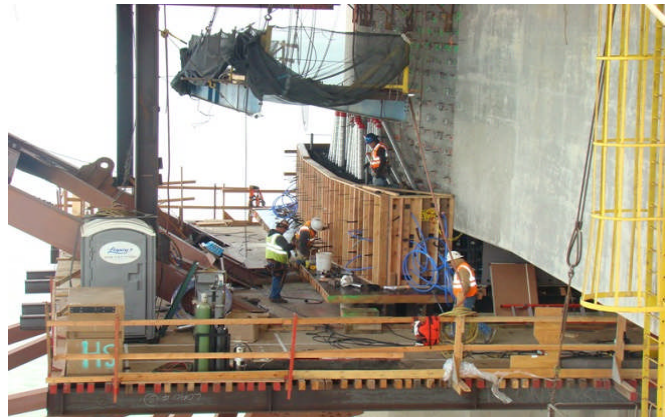
Formwork being installed for the west side of the S1 Shear Key retrofit soffit beam concrete placement.

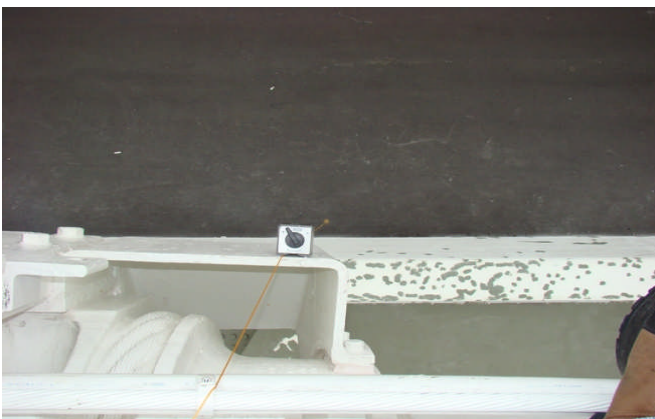
Plumb bob string attached to the side of the cable band shield at EPP98 looking down which denotes encroachment into traffic given the elevation.

- Measured the traffic envelope at panel point 98 where the cable band on both sides is in the traveled way. Cable bands 96 and 100 were also measured to define the cable geometry in this region and to pinpoint cable band 98 as the only point of encroachment. Used the total station (reflectorless feature) with an arbitrary coordinate system. A plumb bob was used at panel point 98 only as a check to the measurements taken with the total station, see photos below for more details. Processed and analyzed the surveying data of the total station points. Compiled and summarized the data to simplify the information being presented. Finally sent an email to pertinent Caltrans personnel (Bill Casey and Ade) with the results that basically show the cable bands at panel point within the traffic envelope.

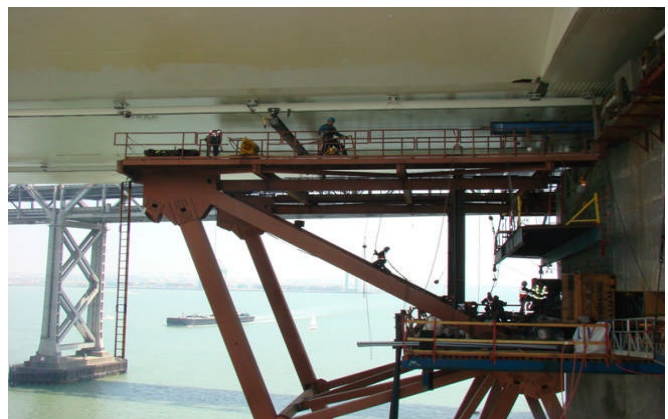
ABF ironworkers removing a crossbrace on the E-Line temporary truss to enable S2 Shear Key saddle installation with the temp. gantry beam.

Shear Key retrofit. Spent most of the day removing a cross brace of the east side E-Line temporary truss with the temporary gantry beam on the traveler rails, see photo below for more details.
